**Initial Site Assessment
Results
for
Southern Illinois Railcar
7570 Ottawa Road
Cairo, Ohio**

Matt Elkins
Project Geologist
Allied Environmental Services, Inc.

January 7, 2009

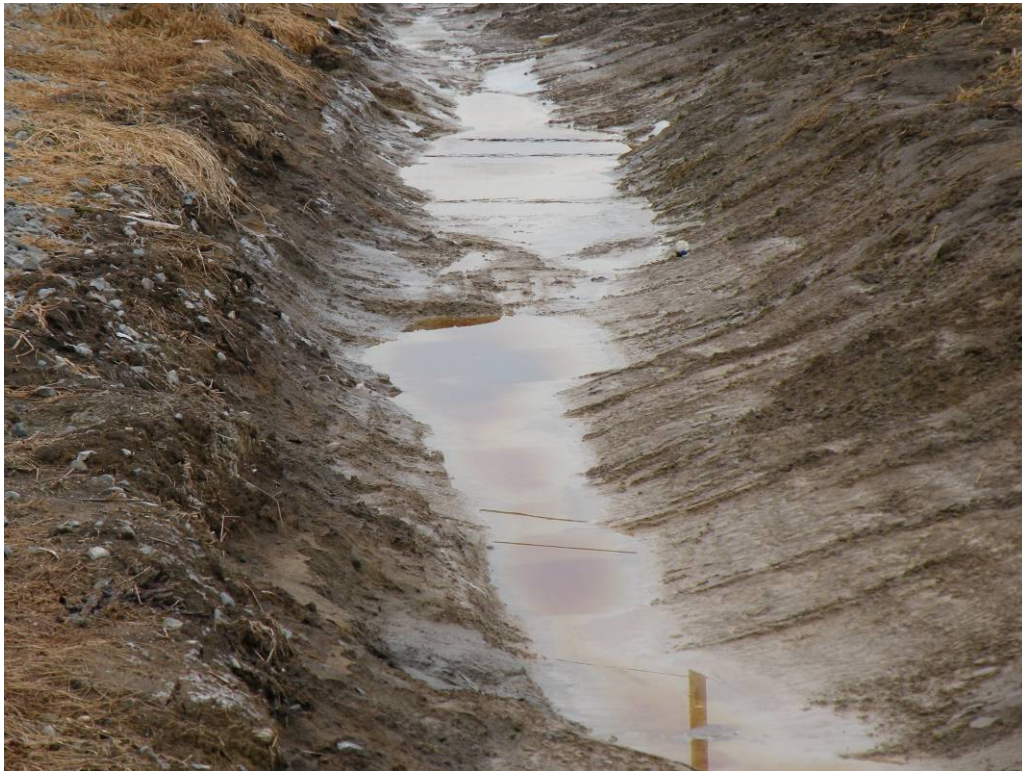
Photo 1: Stagnant surface water on-Site separating into two phases.

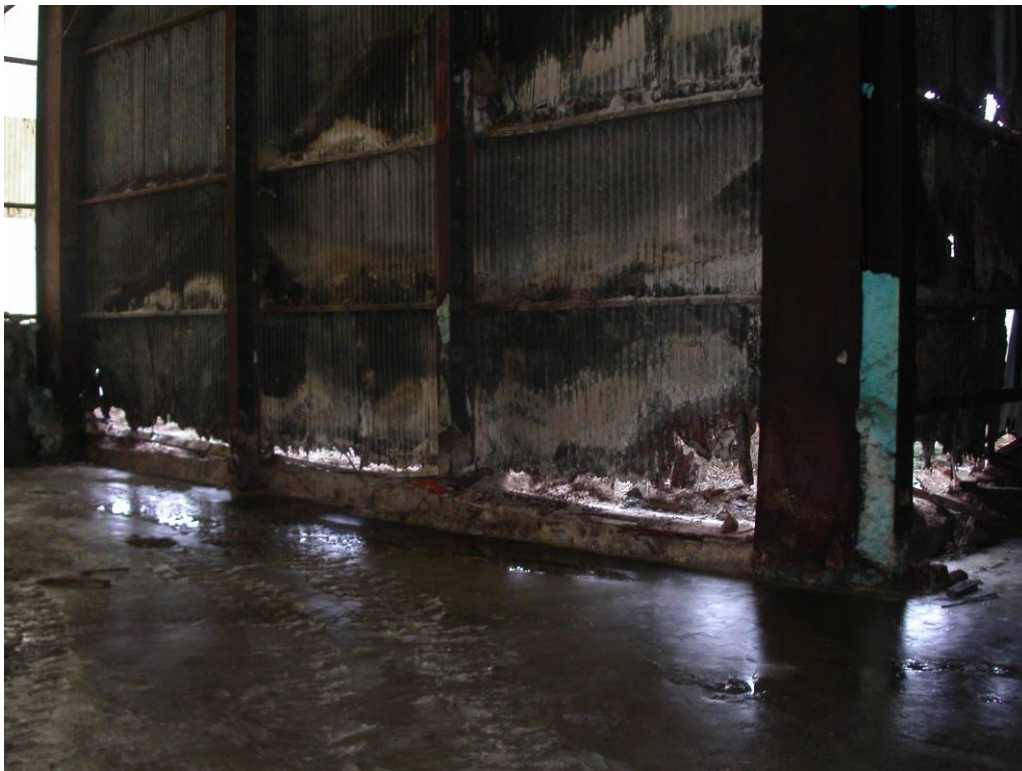
The siding and roof of this building are presently in a deteriorated condition, and, because of this deteriorated condition, historical fertilizer storage and the bulk fertilizer that remained in this building have contributed to surface water contamination. Siding and roofing materials are missing from this building and this allows rain into the interior of the building. Likewise, the drag-pit/basement fills with water and floods the floor of this building. Because of these two factors wet conditions have persisted inside of the building. Bulk fertilizer stored in this persistent wet condition has simply washed out the deteriorated sides of the building onto the adjacent soils and into the North Ditch (see Photograph 2).

Photo 2: Deteriorated side of the North Warehouse where fertilizer can wash out onto the soils adjacent to the building.

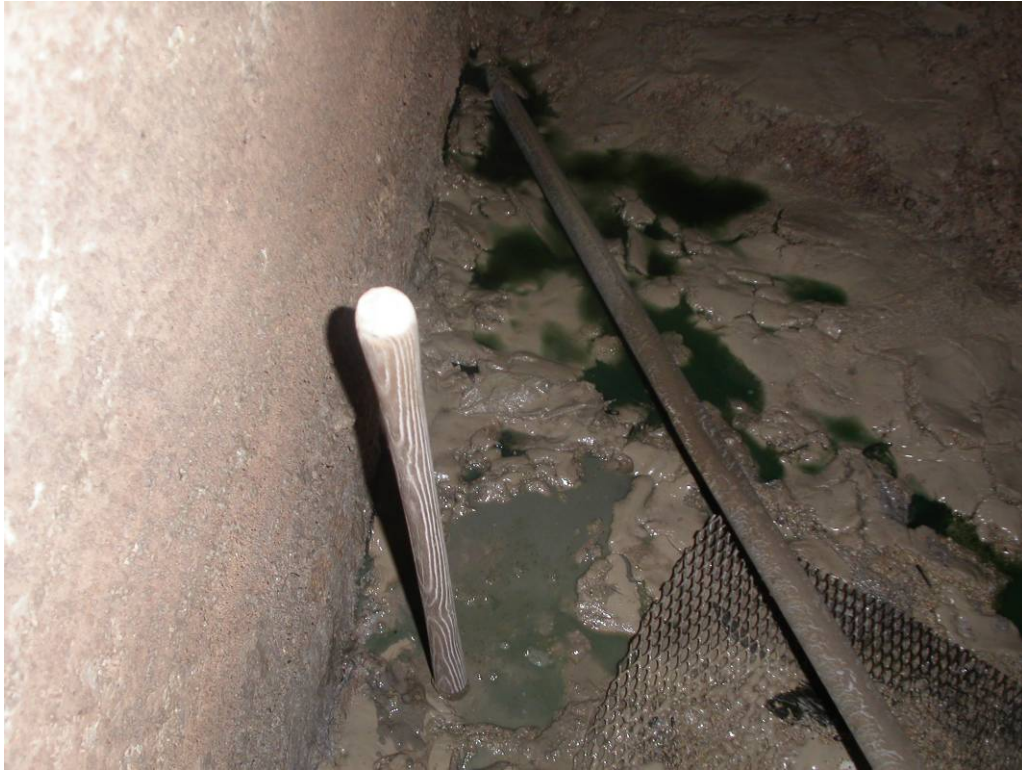
As previously stated, this structure acts as a pathway for elevated ammonia-N concentrations in deeper soils of the immediate area. It acts as a pathway because of its present condition and because this structure was historically utilized to handle fertilizer products passing through the building. Presently, this structure contains approximately 4-feet of sludge material, which is likely a mix of water and remnant fertilizer material. Photographs of the interior condition of this structure are presented as Photograph ## and 3 in Appendix C.

It should be noted that this structure collects large amounts of water which likely enter the drag-pit/basement through the manway access present on the exterior of the building or through an underground structure, which appears to be a scale, adjacent to the drag-pit/basement. The water collecting in this structure takes on a very bright green color, likely due to direct contact with remnant bulk fertilizer in the drag-pit/basement. When this structure fills completely with water it then becomes a surface water problem by draining into a nearby catch basin and flooding the floor of the North Warehouse.

Photo 3: Sludge condition in the interior of the North Warehouse Drag-Pit.
